# **Concrete Maturity Testing in Michigan**

February 2004

Andrew J. DeFinis P.E.  
Tony Angelo Cement Construction Company  
Novi, Michigan

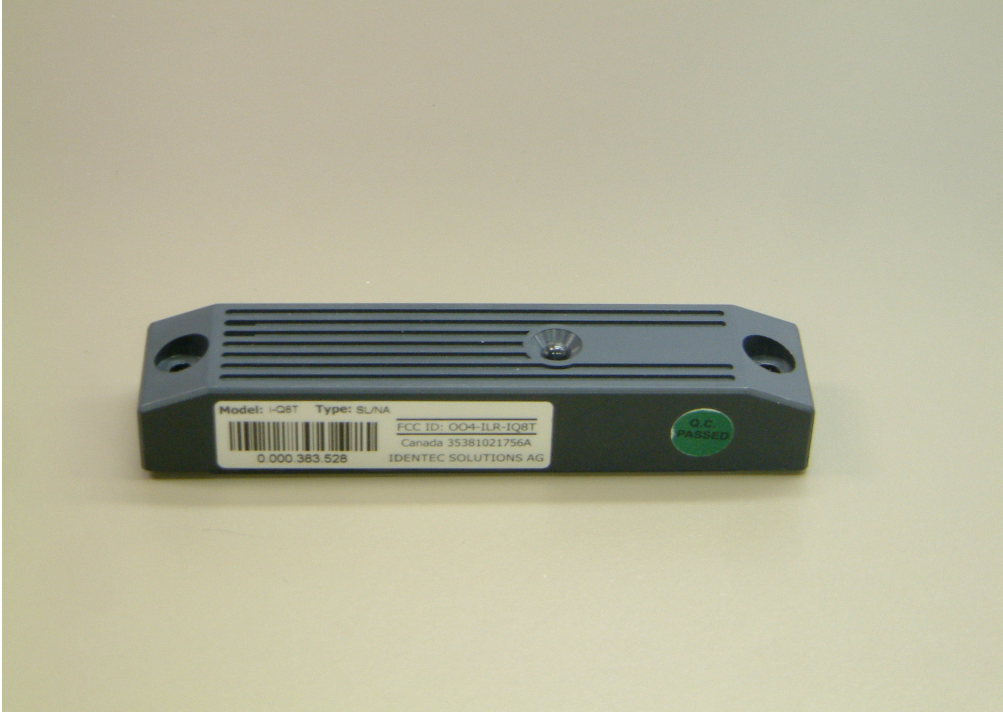
Figure 1 Identec Solutions IQ8T Tag

The i-Q8T tag has the ability to capture the ambient temperature and store it within its memory. The tag is 5 1/8" long, 1 1/16" wide and 7/8" high and weighs 1.75 ounces. It contains a temperature sensor, memory storage of 8Kb, a battery with a 5-year life and the ability to transmit radio signals. The i-Q8T will record the temperature at set intervals as specified by the user. For this study the default setting of 30 minutes was used. The i-Q8T stores 1024 data points in the tag memory and operates at 915 MHz. It can be read from a distance of over 300 feet in clear air, but buried in 5' to 8" of concrete, its range is about 20' with the unit we had.

The Concrete Maturity Monitoring System is a combination of technologies. There are three main components to it: 1) A radio frequency tag developed and patented by Identec Solutions of British Columbia, 2) Software developed by International Road Dynamics (IRD) of Saskatchewan, 3) A portable (in our study we used a Compaq iPAQ) hand held device which contains a PCMCIA card. The system is marketed by WAKE, Inc. of Sturgis, Michigan, the US distributor. One of the tags is shown in figure 1.

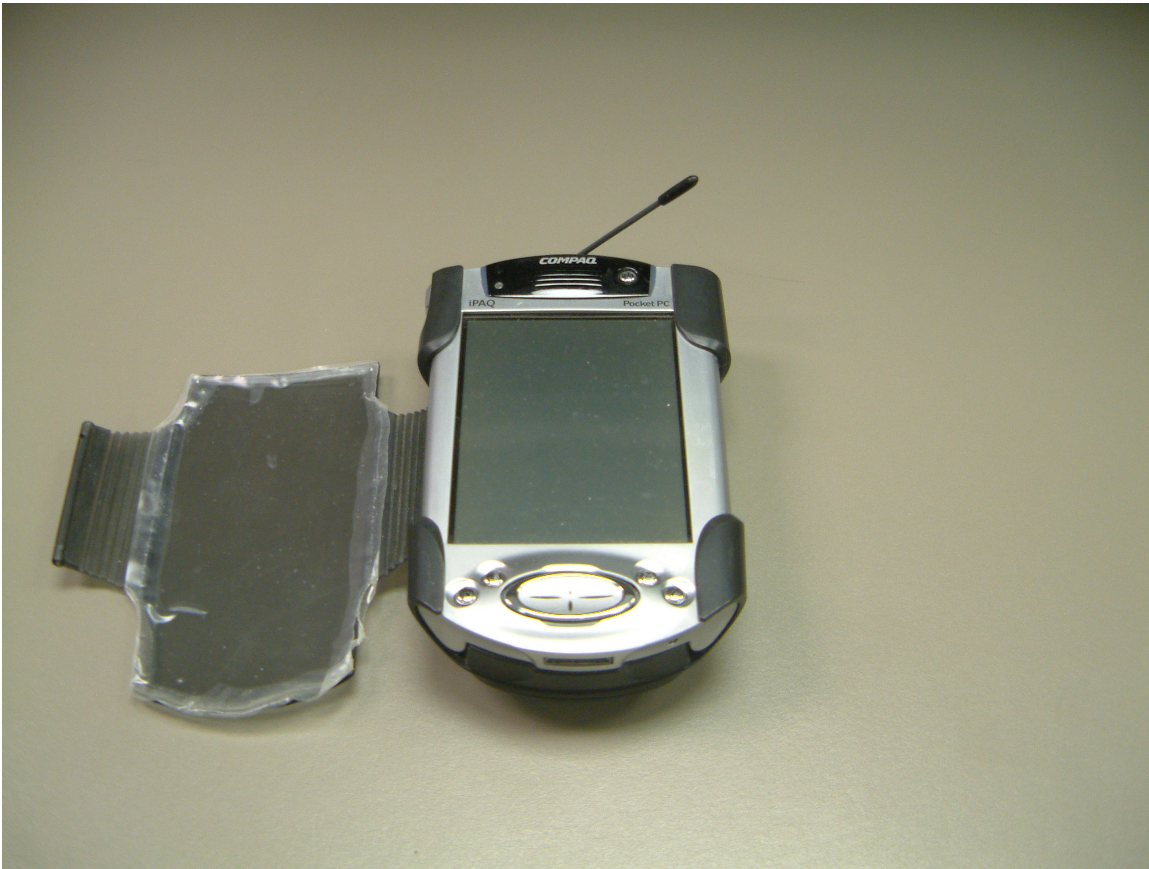
Figure 2 Compaq IPAQ Pocket PC

The software developed by IRD is called Pocket Concrete and will work on portable hand held-devices that use Microsoft's Pocket PC operating system, the unit must have the capability to accept a PCMCIA card. As we used the Compaq iPAQ, Compaq (now owned by Hewlett Packard) has an expansion pack attached to its back which can hold the PCMCIA card. See figure 2 for a picture of the iPAQ. In the iPAQ we used, the PCMCIA card contains a connection for a small quarter-wave antenna to be plugged in.

The combination of the technologies we used is called Radio Frequency Identification (RFID). The antenna emits radio signals which activate the tag and allows the user to read or write to the tags as well as pass commands along to it. The transceiver is located in the PCMCIA card which is connected to the iPAQ unit. The IRD Pocket Concrete Software uses the in-situ concrete temperature along with either the Nurse-Saul equation or the Arrhenius method for calculating maturity. The Pocket Concrete Software exports to a comma-separated file that can be used by Excel. The software exports the following information:

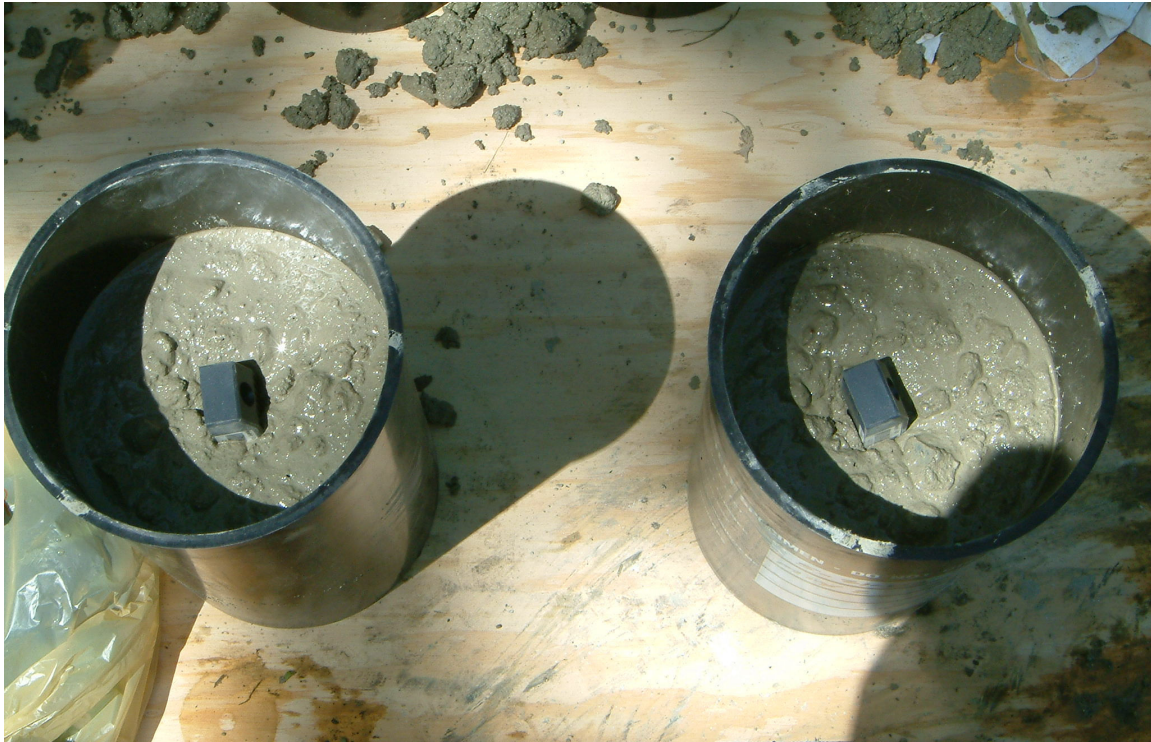
Figure 5 IQ8T Tags placed in cylinders

Two of the cylinders in each set of 20 had an IQ8T tag placed into it. The tag was placed into the center of the cylinder at mid depth. In Figure 5 is a picture showing the tags placed into the cylinders.

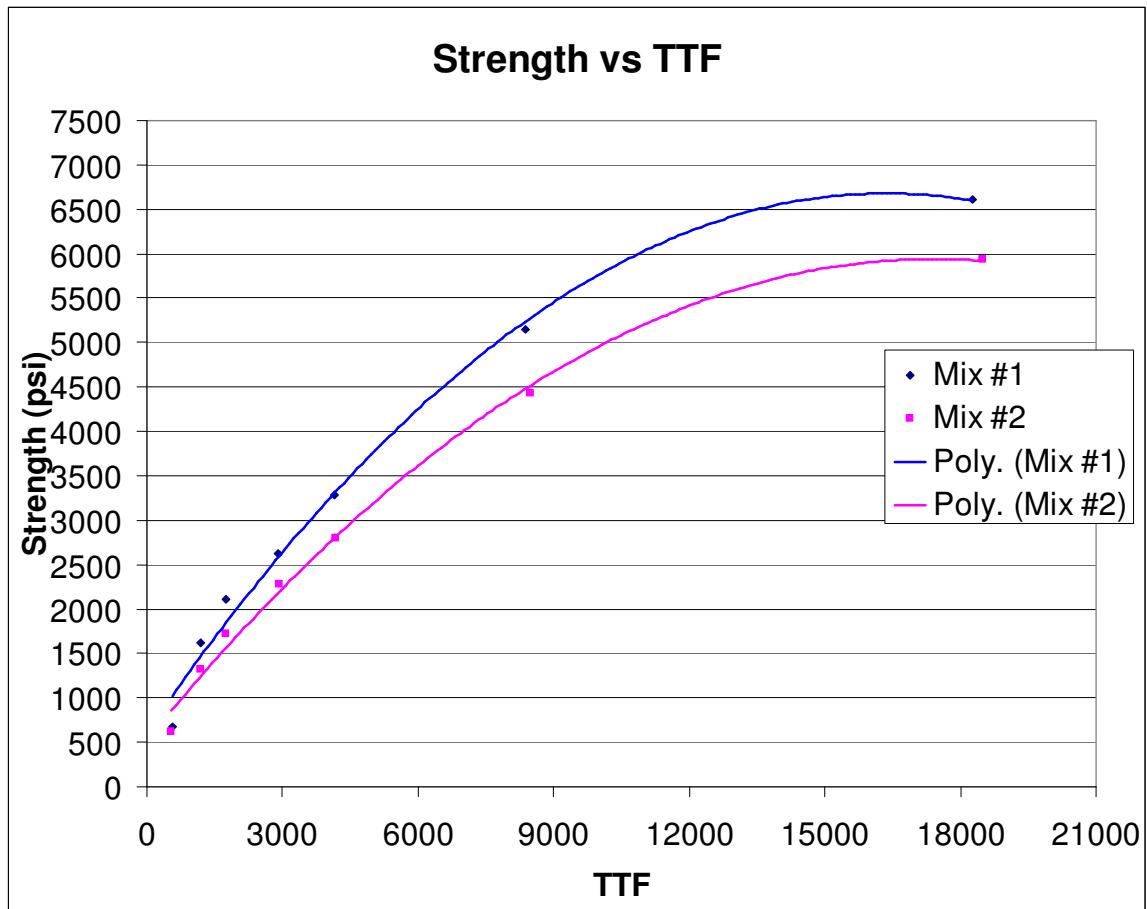
Figure 7 Maturity Curves for Mix#1 and Mix#2

From the cylinder breaks and the TTF readings the following two maturity curves shown in figure 7 were created. The data points have been fitted with a polynomial trend line.

The table in figure 8 shows the TTF readings and cylinders breaks used to make the curves in figure 7

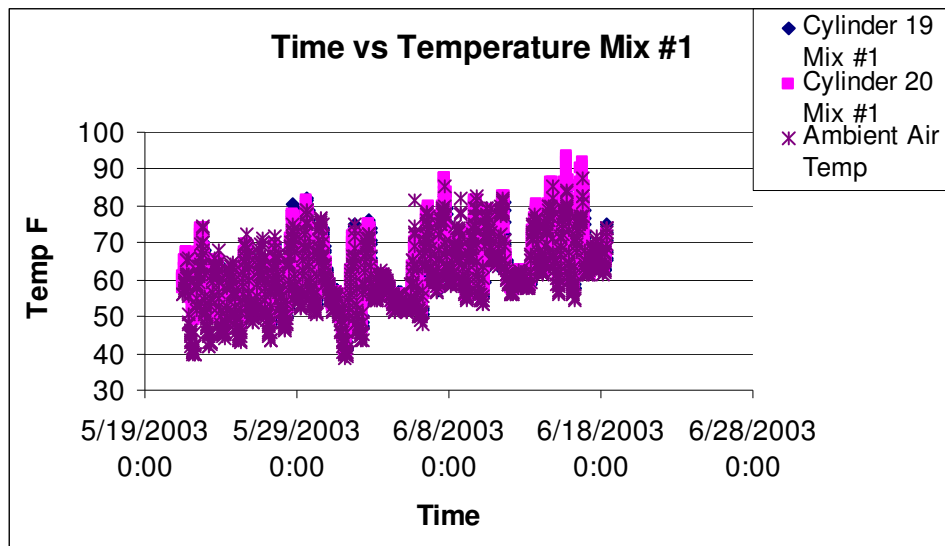
Figure 9 Time vs. Temperature for Mix #1 Slipform

Shown in figures 9 and 10 are the Time vs. Temperature Curves for Mix# 1 and #2.

The curves show the tags that were placed into Cylinders #19 and #20 for both mixes as well as the ambient air temperature. The curves also show that little variation was found between the tags in Mix#1 and Mix#2.

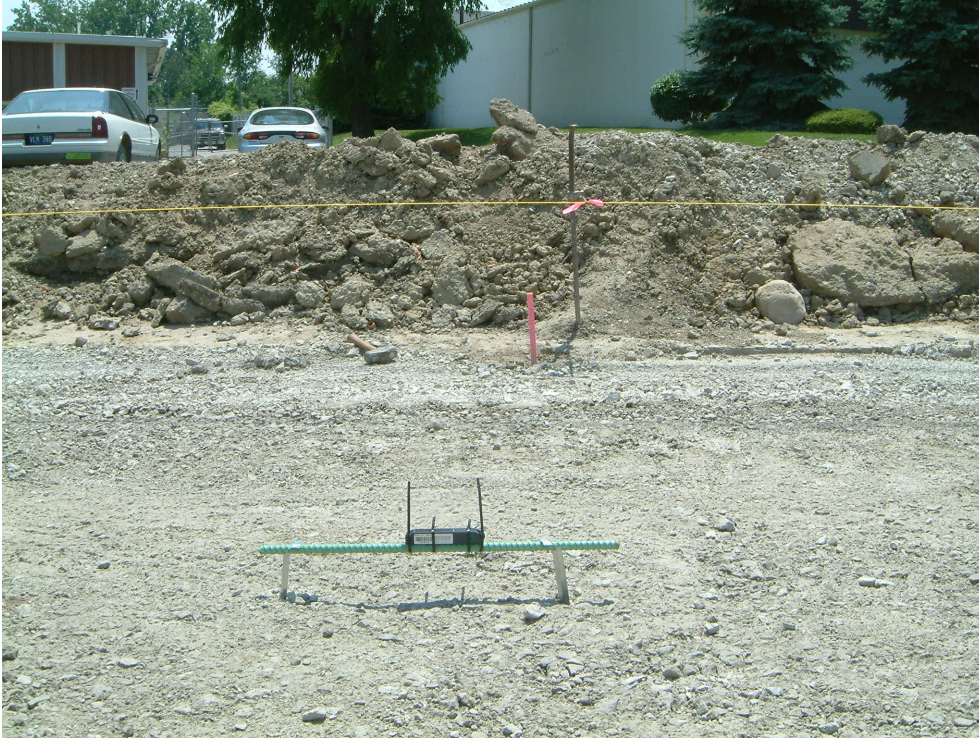
Figure 12, IQ8T tag set up

The IQ8T Tag was placed on to a piece epoxy coated #5 rebar that was 2' long. The tag was fastened to the rebar with four electrical zip strips. The rebar was held up by two tie bar spades at either end. The tie bar spades were pounded into the 21AA gravel base until the top of the tag was 4.5" up from the gravel. The tag was placed at 4.5" since the concrete was 9" and this would place it at mid depth. The tie bar was placed at 2' in from the edge of metal. The tie bar was placed at this location in case the tag needed to be found after the paver passed, it would be easily accessible. Show in Figure 12 is the IQ8T tag set up prior to paving.

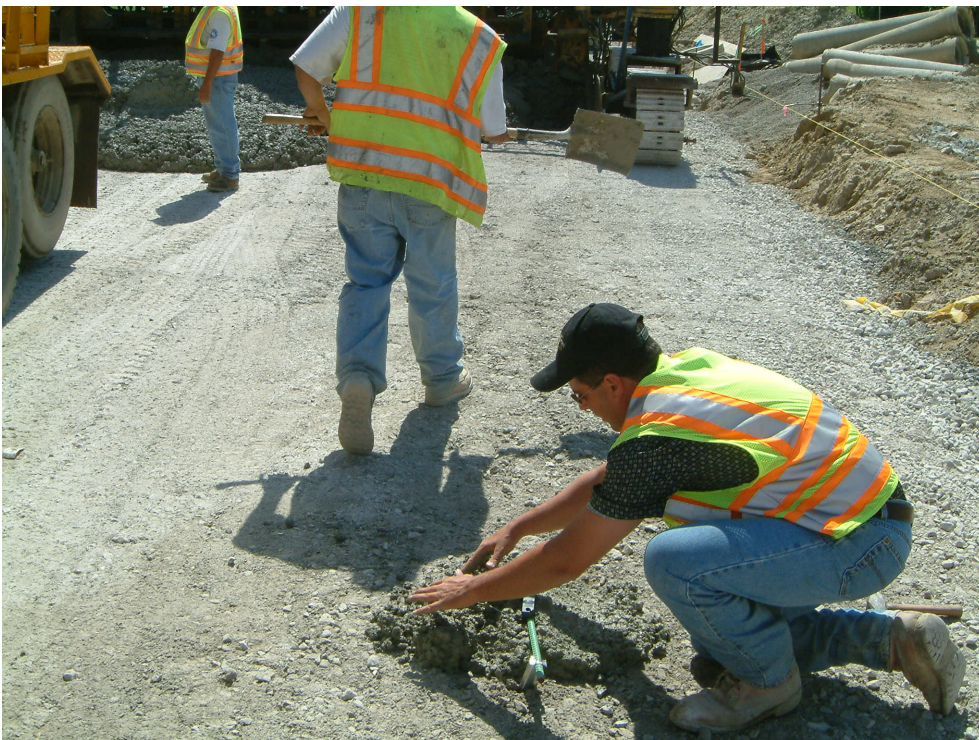
Figure 13, IQ8T prior to first paver

The tag was then buried prior to the first paver with concrete. This is shown in figure 13. This project was paved using a front strike off paver and rear finishing paver.

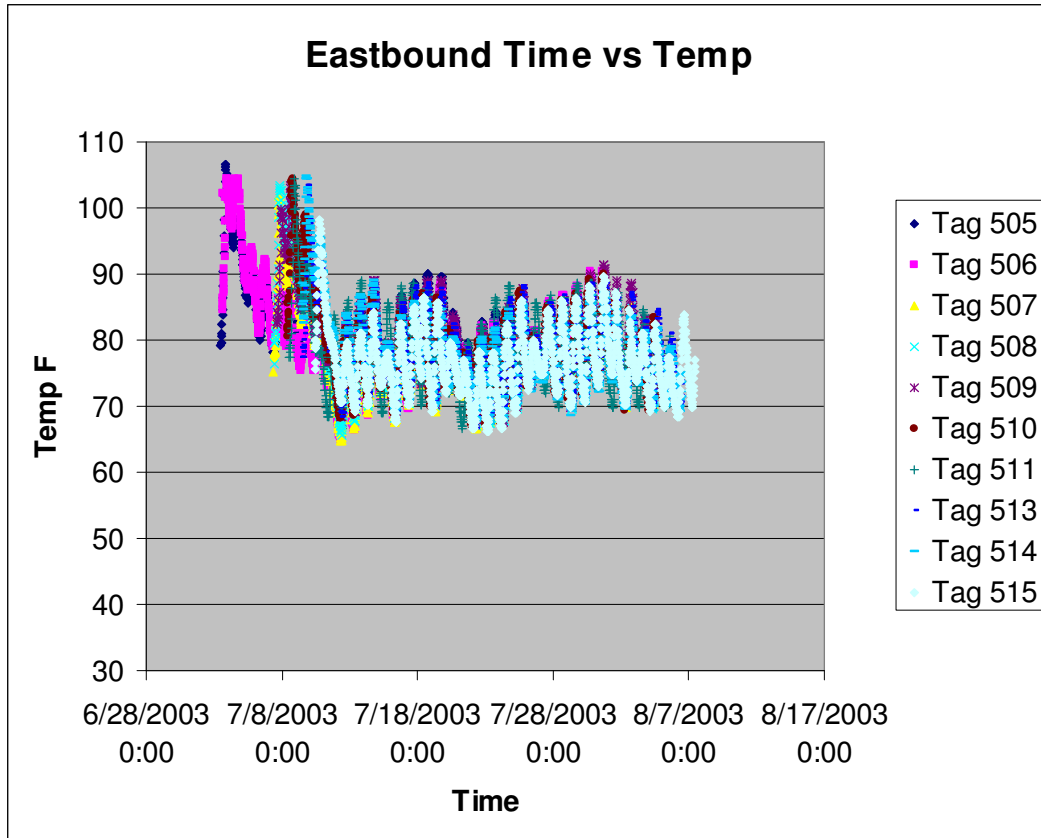
Figure 16, 28 Day Temperature Curves for Eastbound Tags

Shown in figures 16 and 17 are the 28 day temperature curves for the eastbound tag locations.

During this study two curves were made. The paving of the eastbound roadway took place in early July and the westbound roadway in late September. By looking at figure 15 and 16 one can see the difference in temperatures that were present in the slab in the first 28 days. The slab of the eastbound roadway was in the mid 80's F during the day with lows above 60°F. On the other hand, westbound roadway was in the mid 50's F with lows around 40° F. With over two months between the paving of the two sides of the roadway it would be recommended future work to make new a curve prior to the paving of the second side paving. Additionally, the curve could be made in weather that is closer to what it is going to be applied in. Again, by making this change the results of this study would have been impacted.

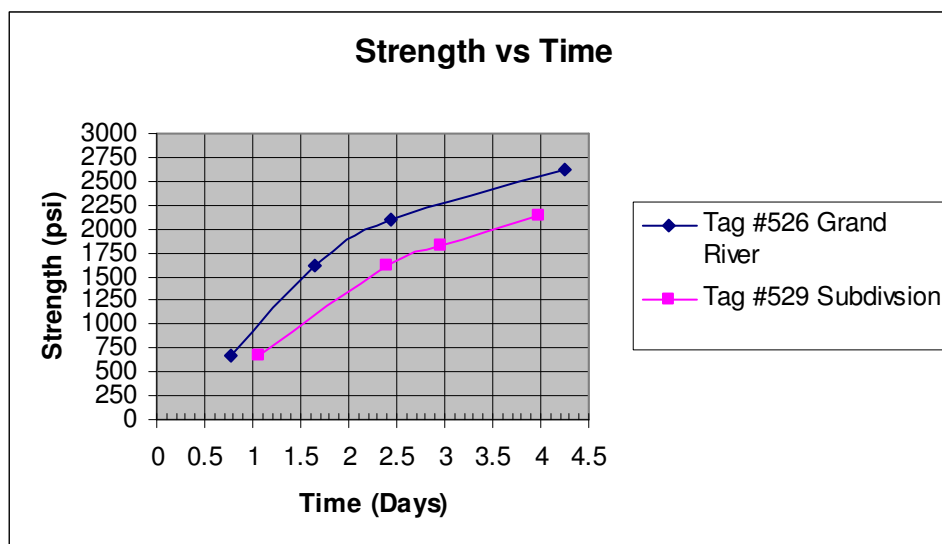
Figure 21, Strength vs. Time

The CMMS could also be used in studying the effects of cold or hot weather on mix designs containing certain materials. For example, it is specified by MDOT that concrete placed in Michigan after October 15 should not contain any Ground Granulated Blast Furnace Slag (GGBFS). The GGBFS will slow down strength gain in cold weather. However, if one were to place concrete with GGBFS and monitor the strength gain a temperature dependent specification could be developed instead of date specific. The maturity system would provide data to the exact impact that the cold weather is having on the strength gain. From this data temperature specific ranges with the amount of GGBFS could be specified. Shown in figure 21 is two strength vs. time curves of concrete both containing 35% GGBFS in different weather conditions. The curve labeled #526 Grand River was placed on September 25, 2003. Over the 4.25 day period for this curve the average concrete temperature was 65°F and the average air temperature was 57°F. The curve labeled tag #529 Subdivision was placed into a subdivision on November 15, 2003. Over the 4 day period for this curve the average concrete temperature was 57°F while the average air temperature was 45°F. The mix designs for both projects were the same except the subdivision used 2NS Hot sand. Even though the two concretes were placed during different weather conditions, the 2NS Hot has kept the subdivision concrete with in 450 psi of the Grand River concrete at 4 days. An expanded study using this type of comparison would be a great tool to be used in creating a temperature specific specification for GGBFS use in Michigan.
